# Coastal Stabilization Proof of Concept

Documented Great Lakes Case Studies & Client Installation Framework

# Grand Haven, Michigan

# Manistee, Michigan

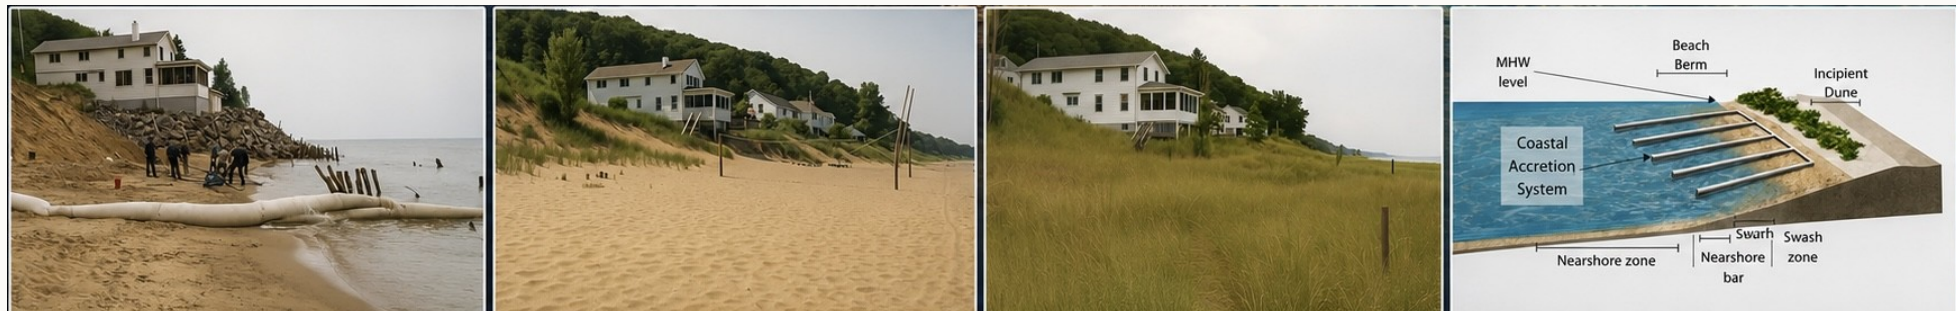
**INSTALLATION SEQUENCE** Placement through recovered beach to mature vegetated dune, with the Coastal Accretion System shown in section.

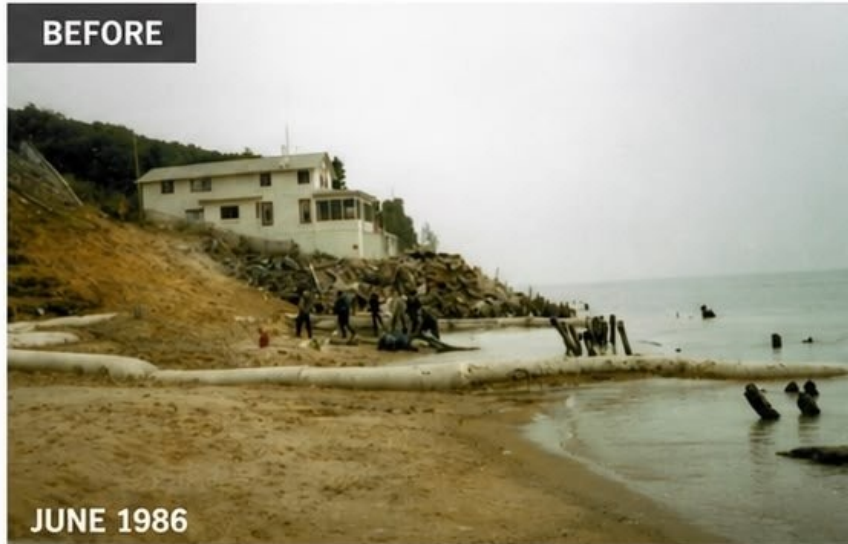
**JUNE 1986**

Six layers of negative sea-walls removed prior to installation of positive energy system

Six layers of failed seawall were removed from the Grand Haven site before the recovery system was installed. Each layer was a prior attempt to hold the shoreline with a hard structure, and each had been overtaken by the same erosion it was built to stop.

Six layers of negative sea-walls removed prior to installation of the positive energy system.

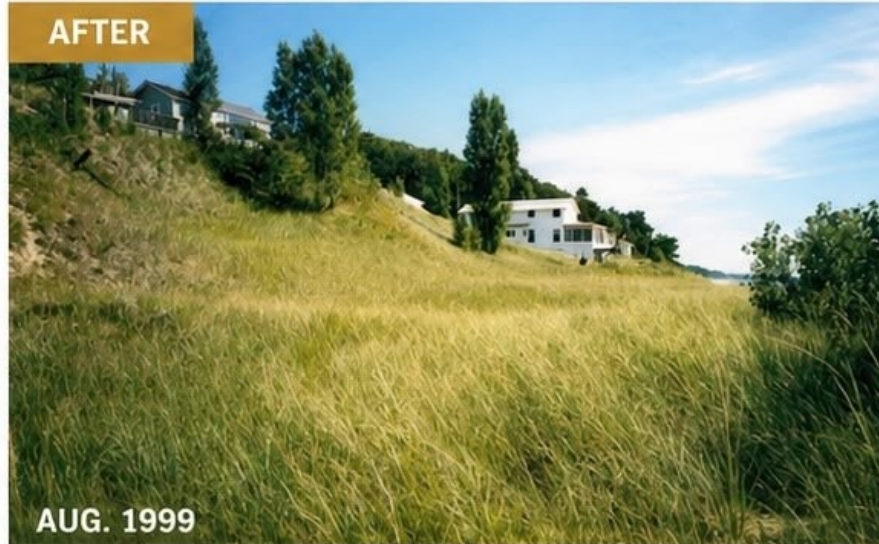
**AUG. 1999**

Patented undercurrent stabilizers that helped reverse beach erosion are now buried by rising sand levels

The site is now a vegetated dune. The system that recovered it is buried beneath the sand it captured.

Patented undercurrent stabilizers help reverse erosion and are now buried by rising sand levels.

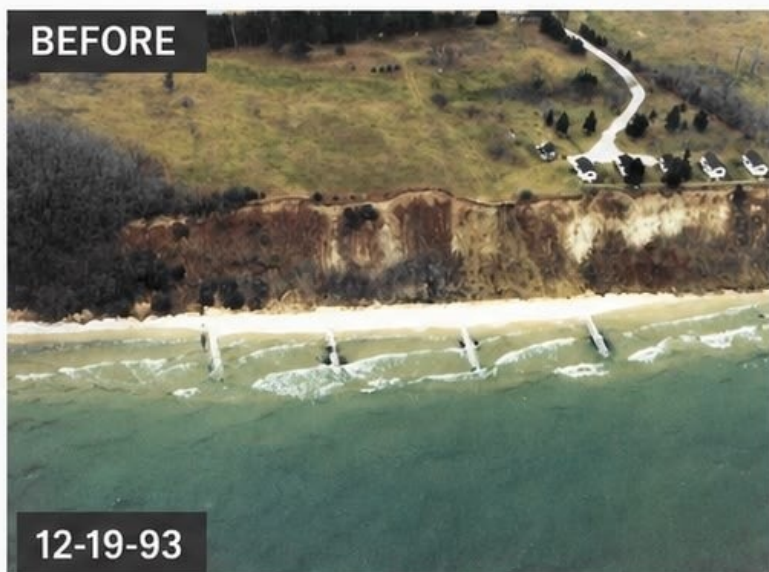
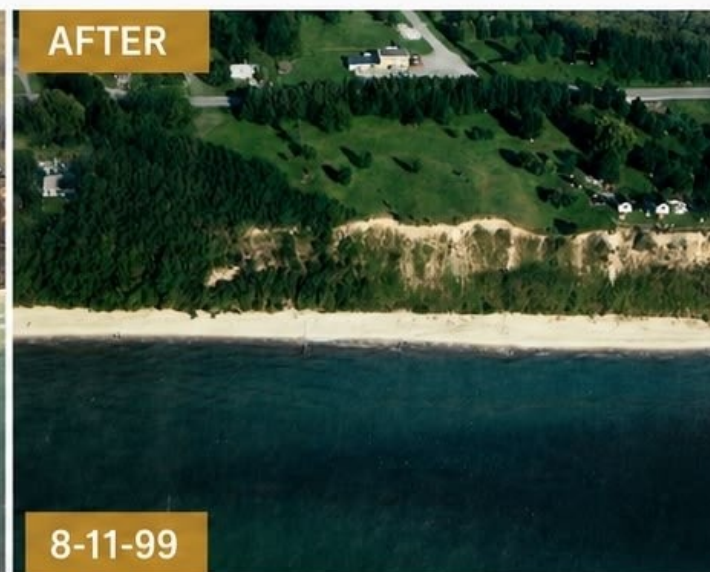
State of Michigan project located north of the federal harbor at Manistee, Michigan.

Patented undercurrent stabilizers installed north of Scotland Yard Cottages.

Project reversed beach erosion north of Orchard Beach State Park.

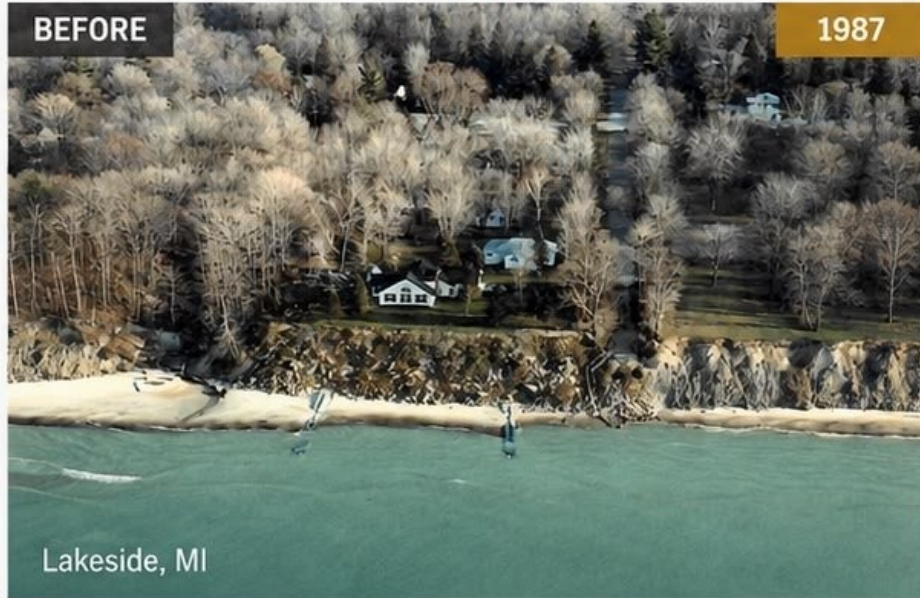
**1987 Before**  
Narrower beach with limited dune width and exposed shoreline pressures.

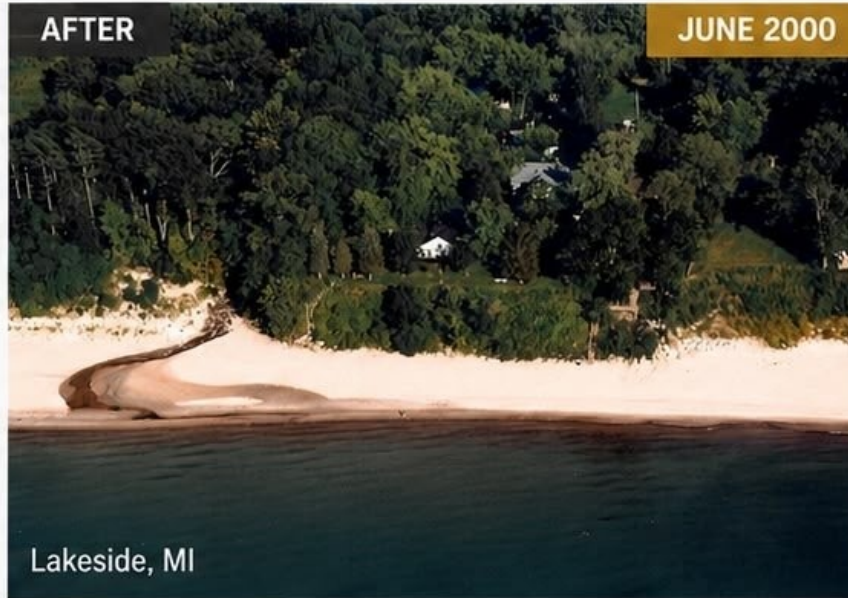
**June 2000 After**  
Substantial beach widening and vegetative recovery with an improved dune and beach profile.

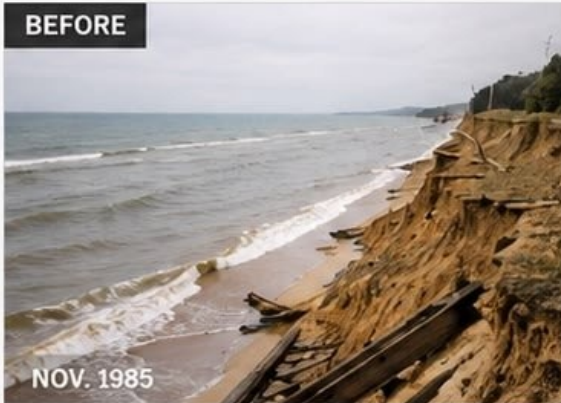
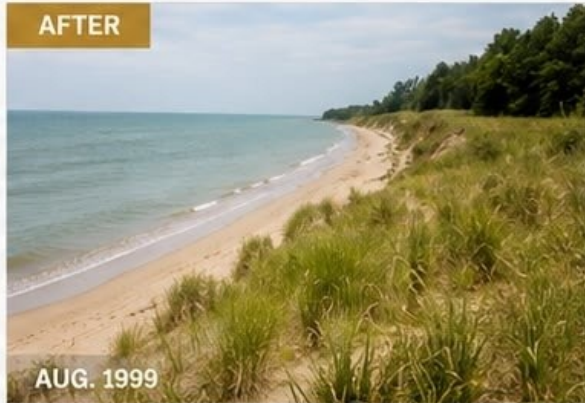
Visible improvement in dune grass, beach width, and shoreline condition.

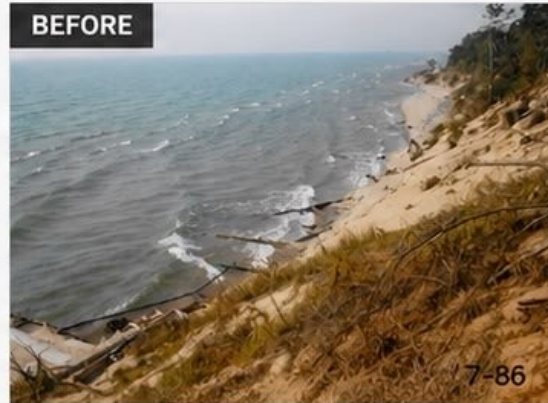
'7-86

Severe erosion next to negative rip-rap.

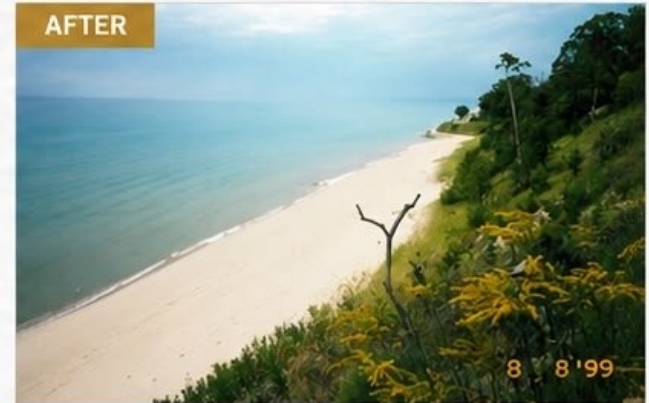
8 8'99

Erosion reversed after Stabilizer System installed next to rock revetment.

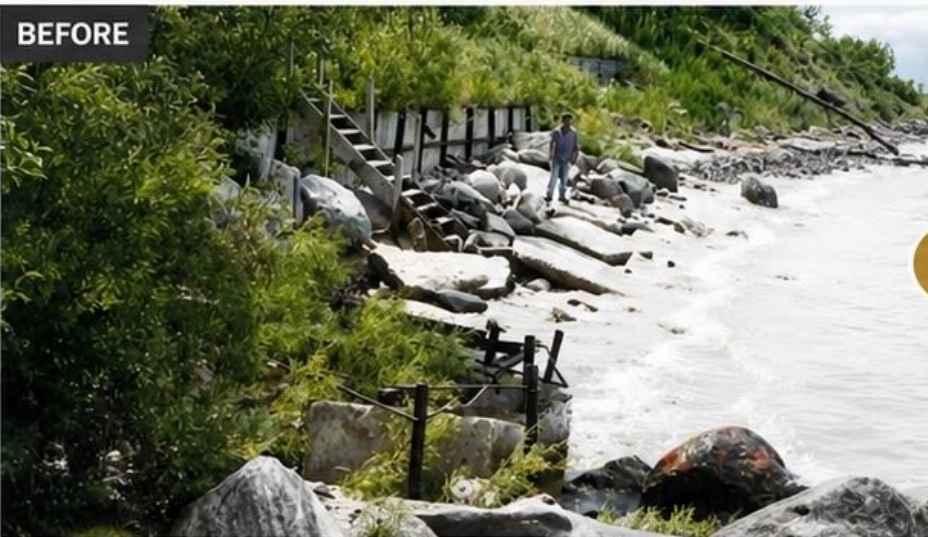
Site condition at Vanderplas before treatment

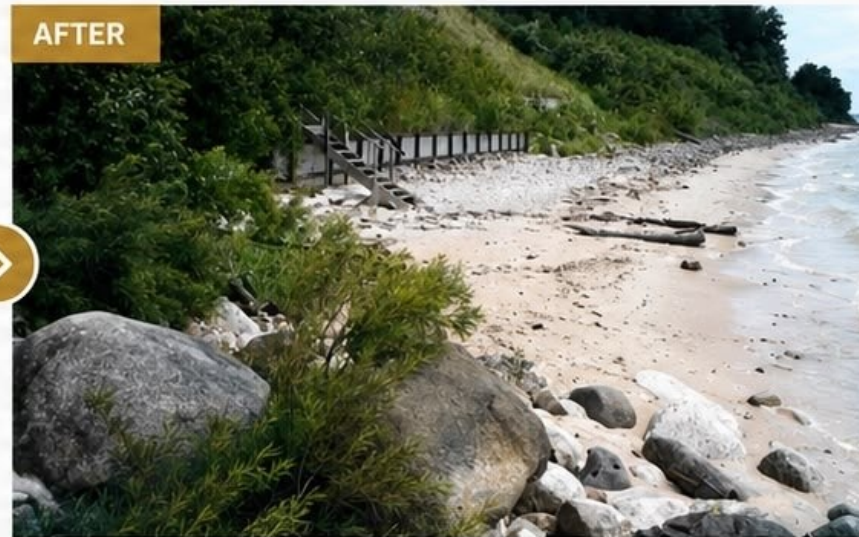
Vanderplas's beach restoration project

Reinforced shoreline with natural stone and structural elements to reduce erosion and protect the bluff.

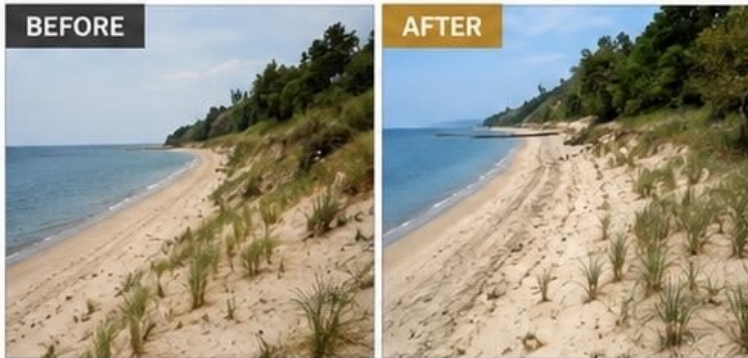
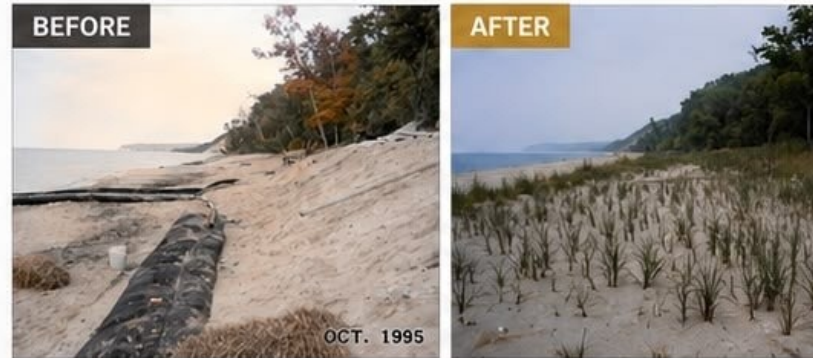
*Additional before-and-after field views show widened beaches, increased dune vegetation, and improved shoreline continuity.*

Significant increase in usable beach width and sand volume.

Natural dune plant communities established and expanding.

Smoother transitions and more continuous, resilient shoreline.
